# Determination of earthquake resistance of historical masonry inn with finite element analysis

**Keywords** Finite element analysis · Historical inn · Seismic performance · Durak Han

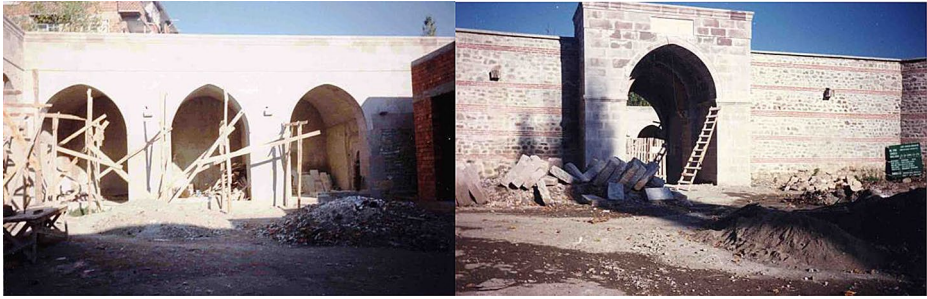
**Fig. 7** 3rd period of inn photographs (inside the yard and entrance façade) (Conservation Report of Durak Han 2015)

The third period restoration can be read by the changes in the material and weave of the third period interventions. The third period represents the final restored version (Fig. 7).
